# VSD Analysis Report

Criteria: SF\_MM\_PC  
Name: M42L01-38

Date: Fri Aug 19 2022  
Time: 15:03:34

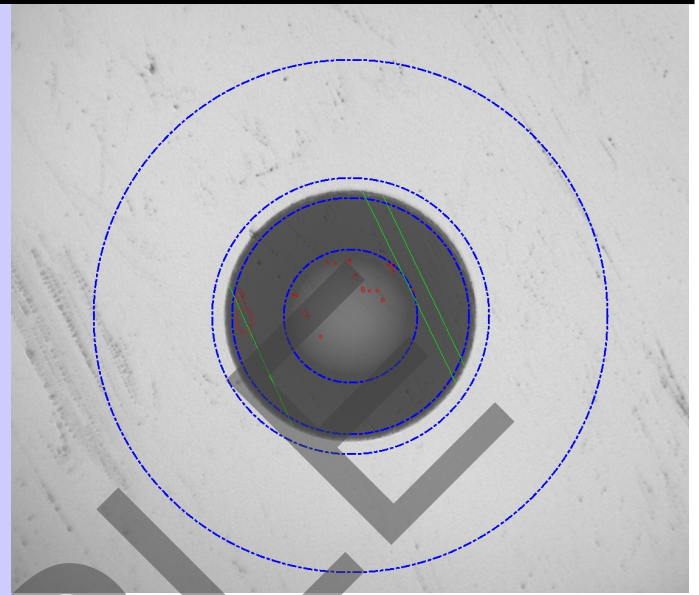
Analysis Image

**FAIL**

Size Range	Num Allowed	Num Found	Num > Max	Size Range	Num Allowed	Num Found	Num > Max
	DEFECT				SCRATCH			
Zone A 0 - 65 um	0 to 5(um)	4	17	0	0 to 3(um)	Any	1	0
Zone B 65 - 115 um	5 to 10(um)	5	2	1	0 to 5(um)	Any	2	0
Zone C 115 - 135 um	N/A							
Zone D 135 - 250 um	20 to 30(um)	5	0	0	Any	Any	0	0
